Big Spring Run Restoration Project Background & Monitoring Results

Pennsylvania
Department of Environmental Protection

Big Spring Run Legacy Sediment Removal and Aquatic Ecosystem Restoration Project

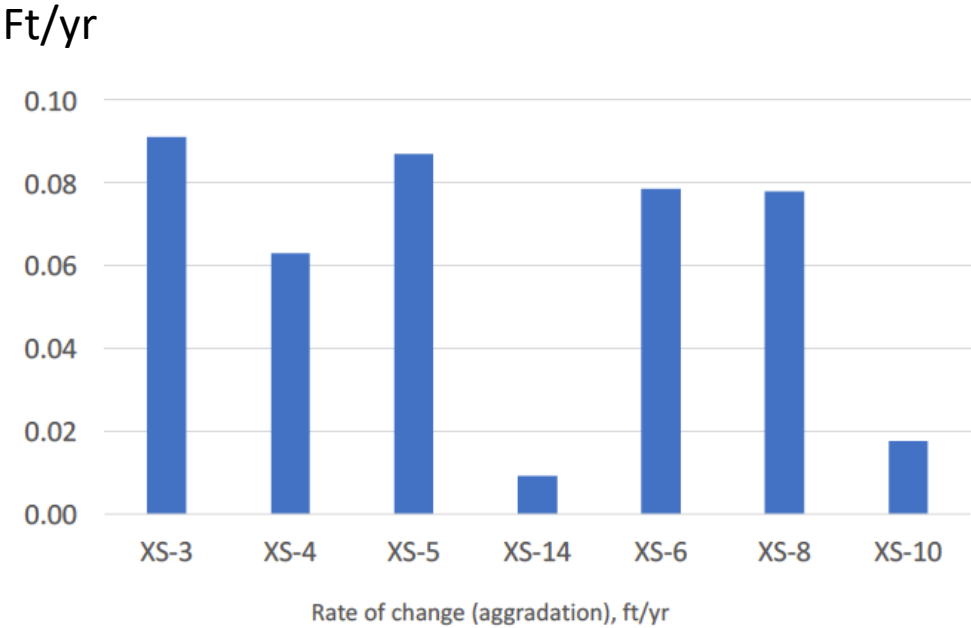
Post-restoration repeat cross section survey locations

Deposition (blue), erosion (orange), and net change (aggradation) for seven cross sections surveyed at least twice between 2012-13 and 2015-17.

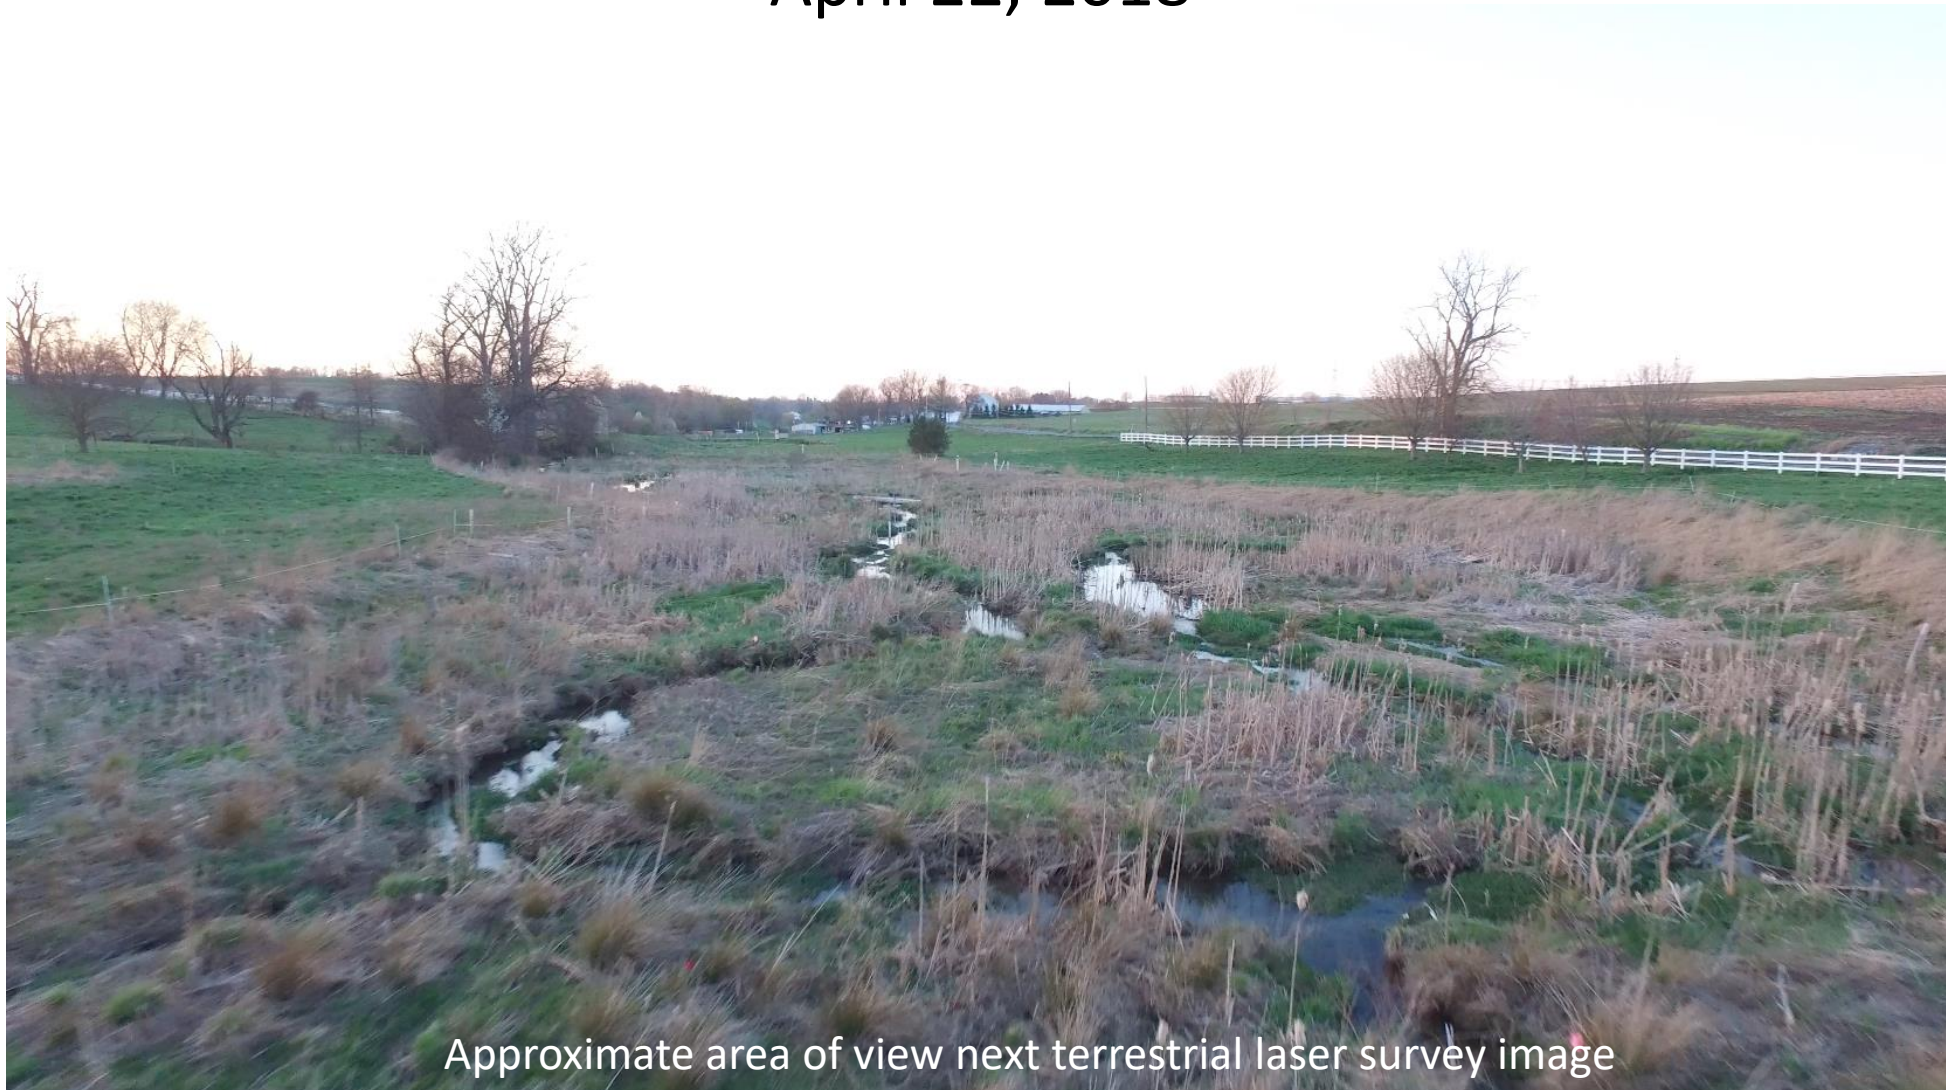
Post-restoration UAV (drone) image of anastomosing channel form April 22, 2018

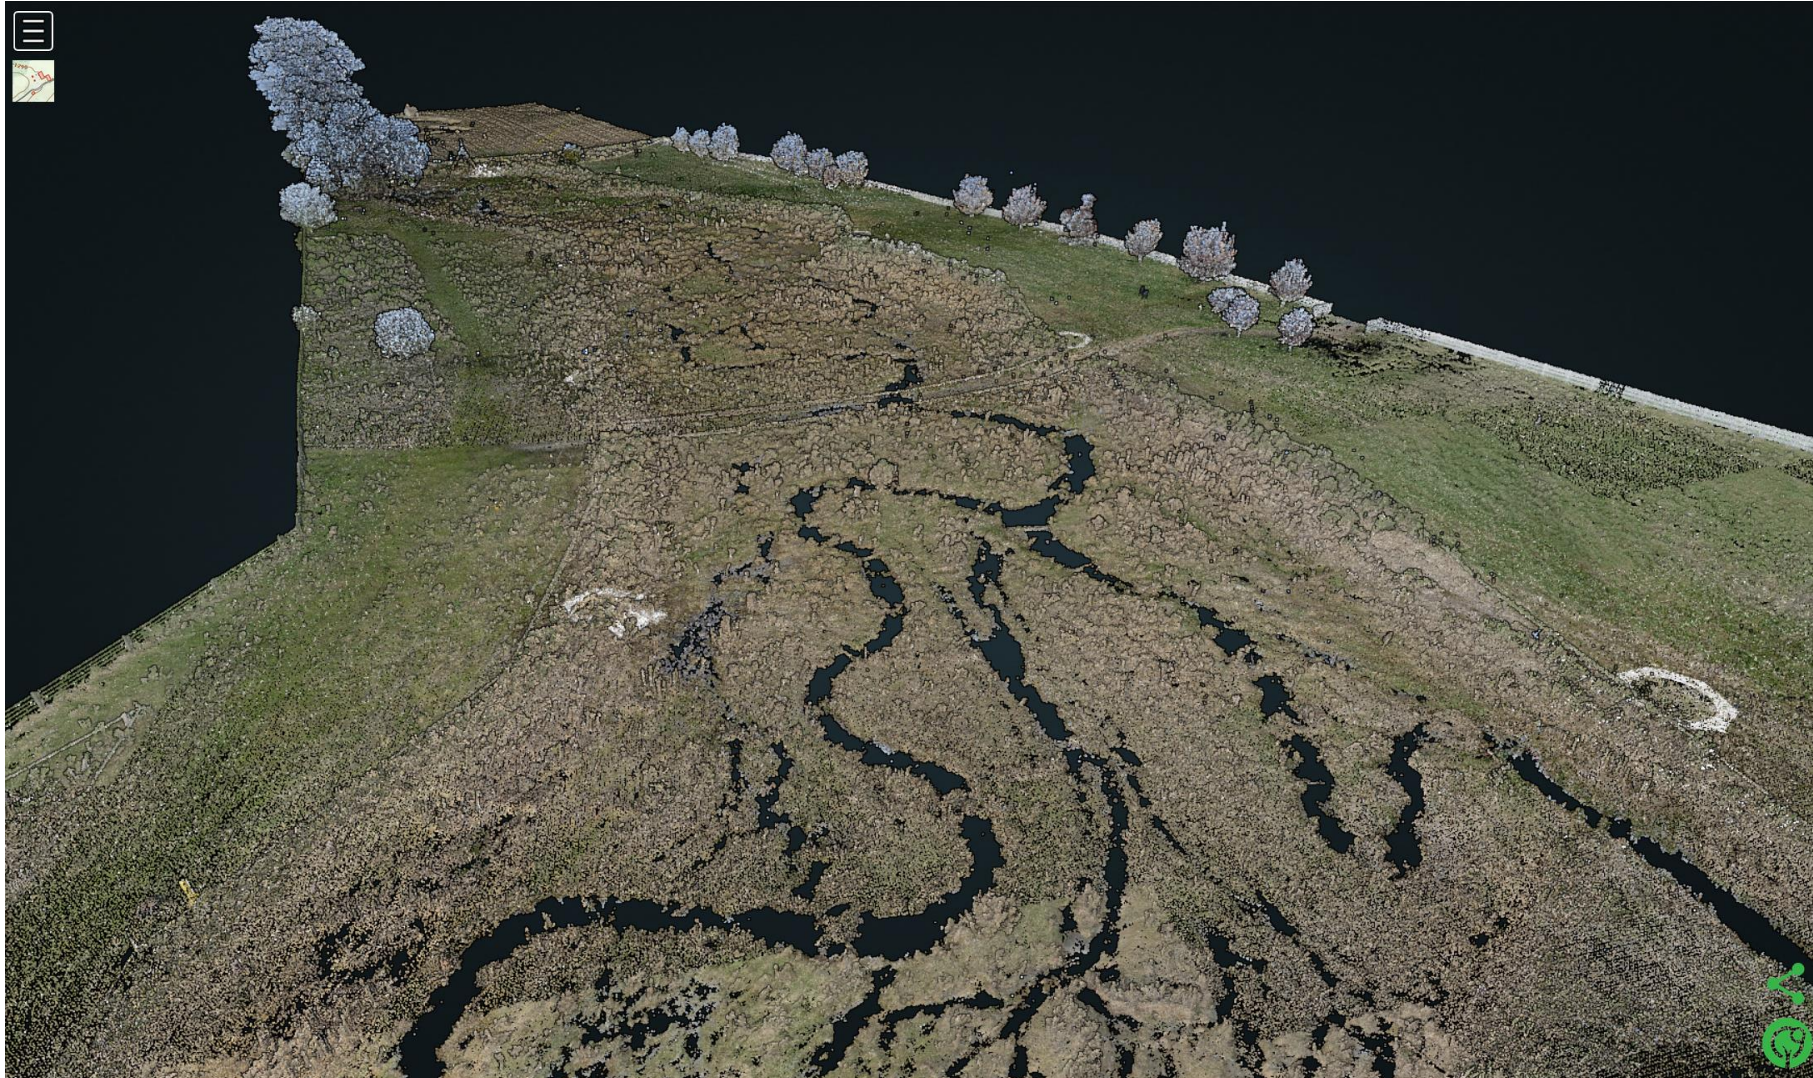
Post-restoration terrestrial laser survey

April 11, 2014

- Small, anastomosing channels were well established by April 2014 - 3 years after restoration.
- Terrestrial laser surveys confirmed that the wetland-floodplain surface remained stable from April 2014 through April 2016 and little change in ground elevation has occurred (i.e., erosion is minimal).
- Fine sediment (silt size) deposition is occurring within the restoration area over time, but it is localized, mostly along channel edges, and on the order a few centimeters.
- Springs that were daylighted when legacy sediment was removed became pools of water connecting small channels that were well established by April 2014.

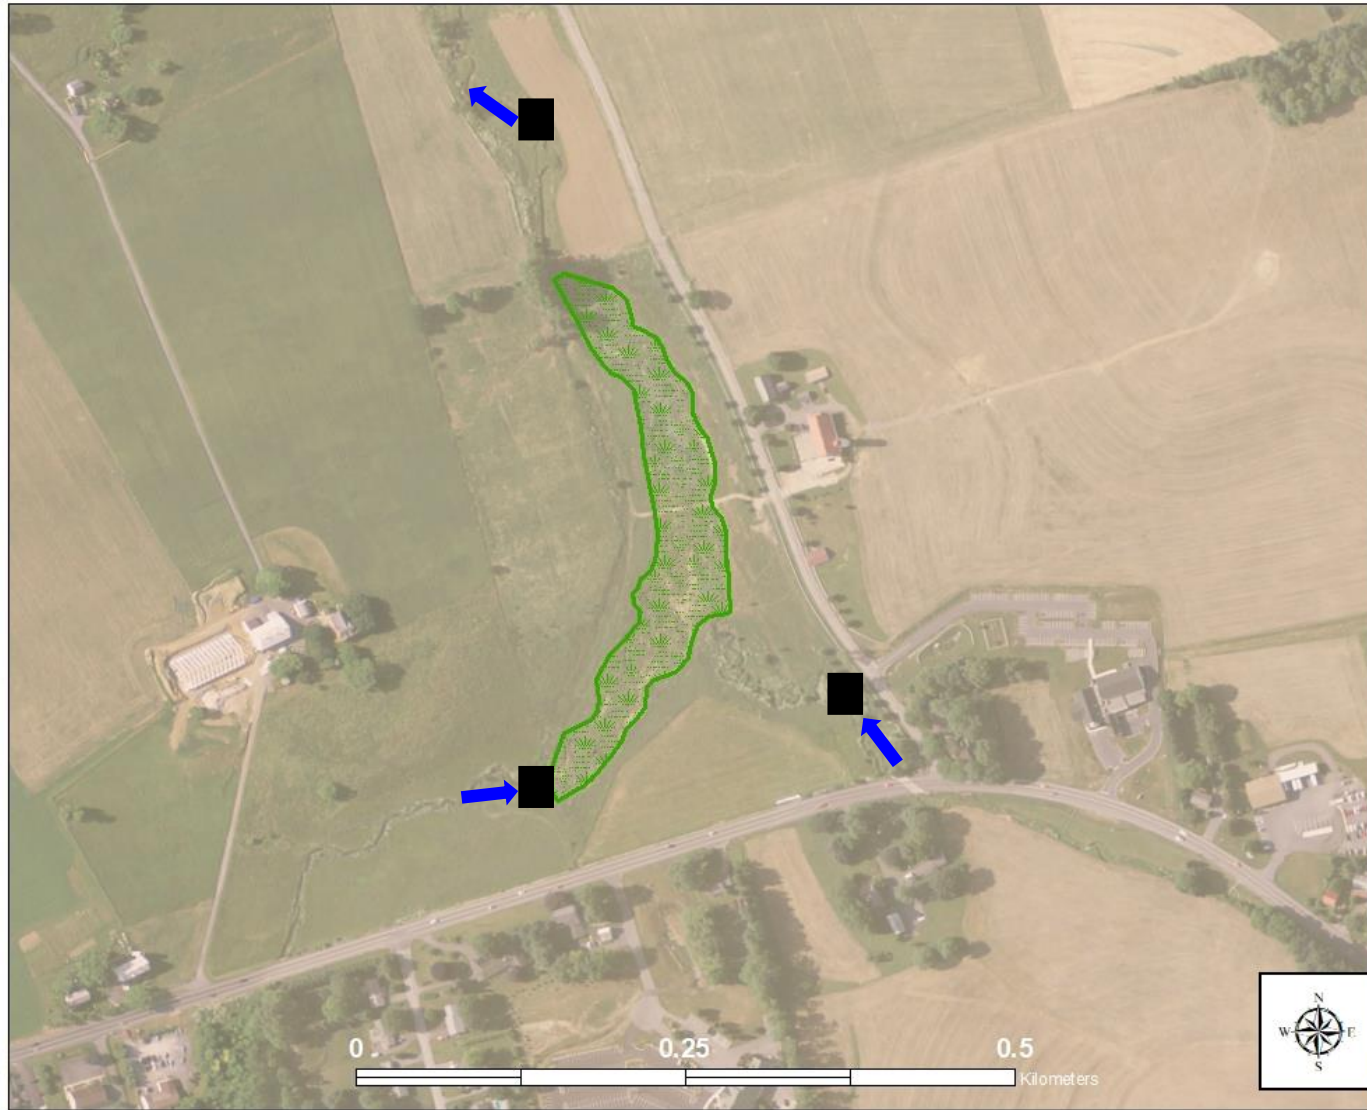
USGS Sample Sites

■ Stream gage locations ➡ Flow direction
